NASA TN D-2438

FREE-FLIGHT TEST RESULTS ON
THE PERFORMANCE OF CORK AS
A THERMAL PROTECTION MATERIAL

by Randolph A. Graves, Jr., and Thomas E. Walton, Jr.

Langley Research Center

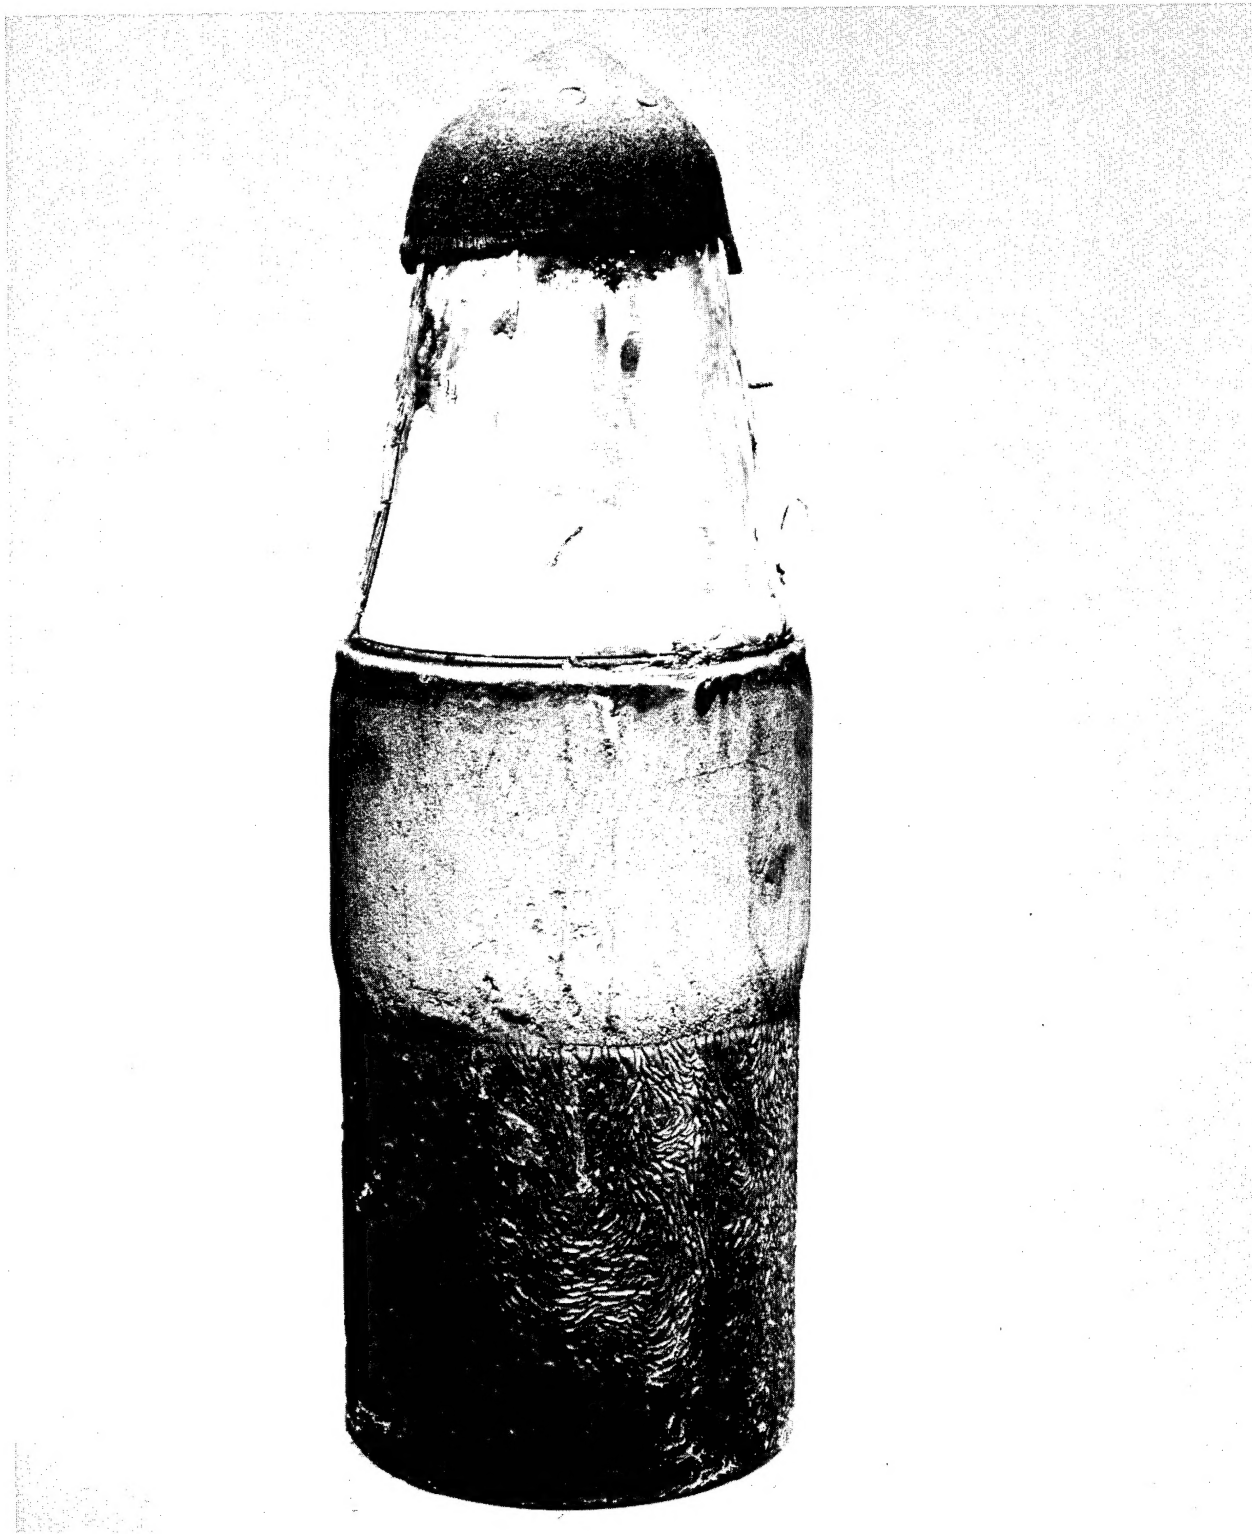
L-63-3991

Figure 29.- Recoverable payload after flight.

A photograph of the recovered payload is shown as figure 29. It can be seen that the hemispherical nose eroded to a conical shape during the reentry.

The epoxy ablation material on the conical afterbody came off during the terminal portion of the flight (about 98 seconds after launch), leaving the cork with a blunted leading edge exposed to the air stream; however, the cork prevented further destruction of the epoxy ablation material on the cylindrical afterbody.
